**THOMAS JEFFERSON PLANNING DISTRICT COMMISSION (TJPDC)
FOR SERVICES IN THE COLUMBIA AREA OF FLUVANNA COUNTY**

**FEMA HAZARD MITIGATION GRANT PROGRAM
DEMOLITION CONTRACT**

ASBESTOS-CONTAINING MATERIALS INSPECTIONS

RE: Asbestos-Containing Materials (ACM) Inspections of the Bryant House, Harry Jr. House, Schoew House and the Ferry House in Columbia, Virginia

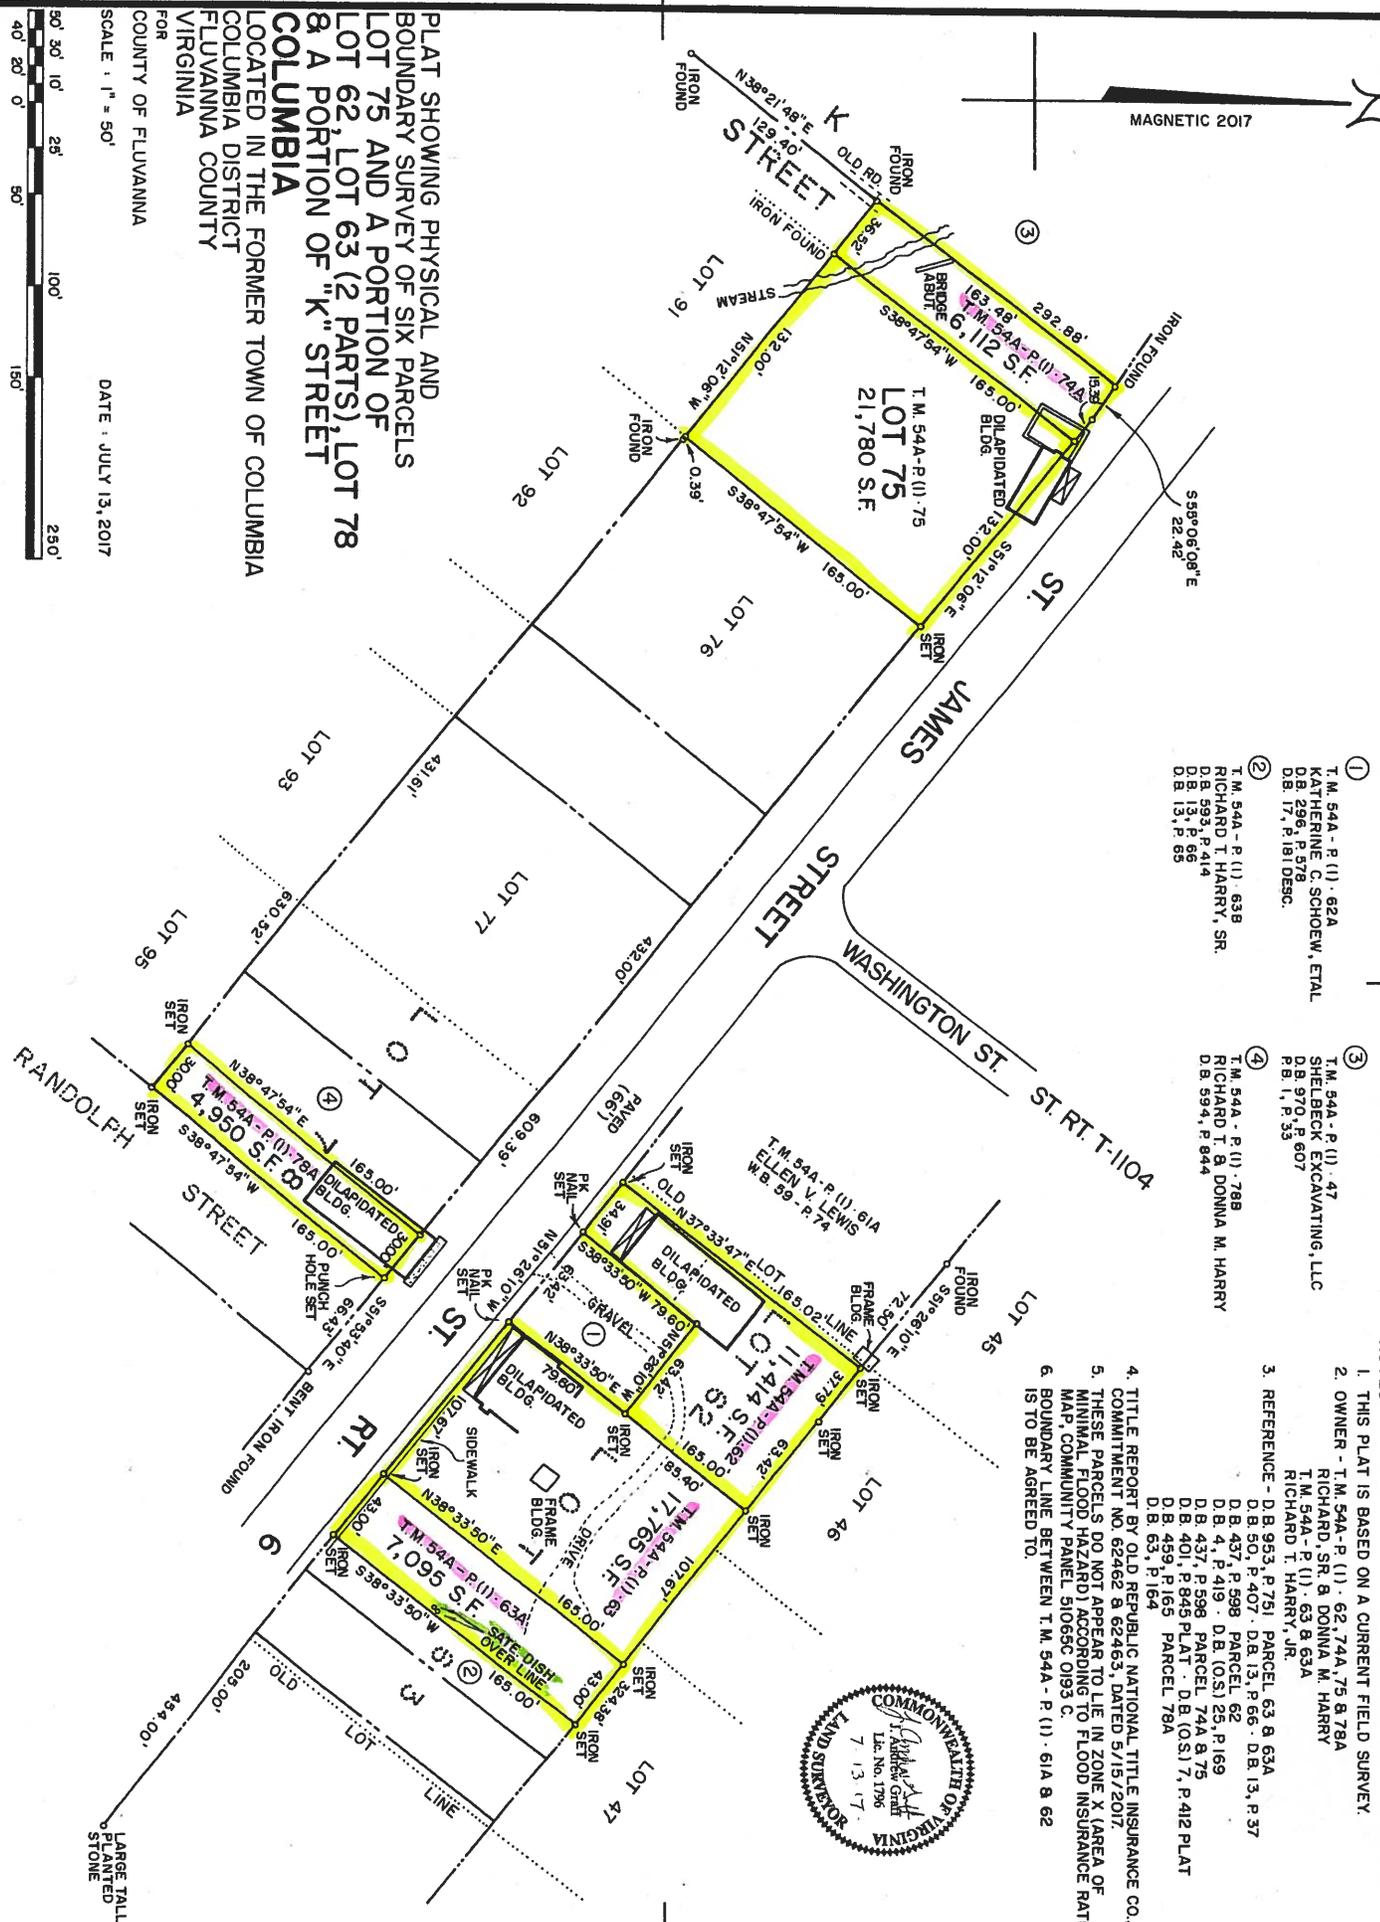
PLAT SHOWING PHYSICAL AND
BOUNDARY SURVEY OF SIX PARCELS
LOT 75 AND A PORTION OF
LOT 62, LOT 63 (2 PARTS), LOT 78
& A PORTION OF "K" STREET
COLUMBIA
LOCATED IN THE FORMER TOWN OF COLUMBIA
COLUMBIA DISTRICT
FLUVANNA COUNTY
VIRGINIA
FOR
COUNTY OF FLUVANNA

① T.M. 54A-P (1) - 62A
KATHERINE C. SCHOEN, ETAL
D.B. 299, P. 578
D.B. 17, P. 181 DESC.

② T.M. 54A-P (1) - 63B
RICHARD T. HARRY, SR.
D.B. 293, P. 414
D.B. 131, P. 65

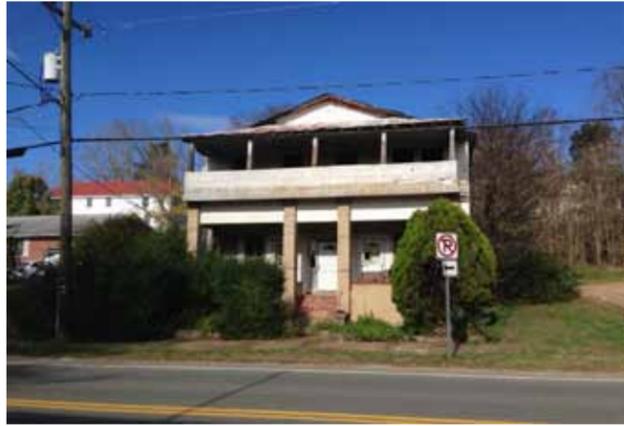
A & B

3. Schoew House (Drawing Reference A&B)

<u>ACM</u>	<u>LOCATION(S)</u>	<u>LABORATORY RESULTS</u>	<u>CONDITIONS (Friable** or Non-Friable, Stable or Damaged)</u>
(1) Siding shingles	Transite cement siding on exterior of house	7% Chrysotile Asbestos	These ACM were non-friable, but in poor condition in certain areas (fallen and/or broken).
(2) 12"x12" Yellow, gray, ivory, brown and blue floor tiles	Main level	2-3% Chrysotile Asbestos	These ACM were non-friable and in stable condition at the time of this inspection.
(3) Drywall joint compound	Throughout inside of house	0.8% (Trace***) Chrysotile Asbestos	These trace ACM were friable, but in stable condition at the time of this inspection.

Address: Saint James Street
 Map Number: 54A-1-62
 Owner: Richard T & Donna Harry
 Map Number: 54A-1-62A
 Owner: K. Schoew, c/o Donna Harry
 DHR 200-21-15

- 54A-1-62: Siding Shingles on exterior of the house, floor tile on main level, and drywall joint compound throughout the inside of the house
 - 54A-1-63 “Ferry House”: Wall and ceiling plaster in interior spaces (intermittent)

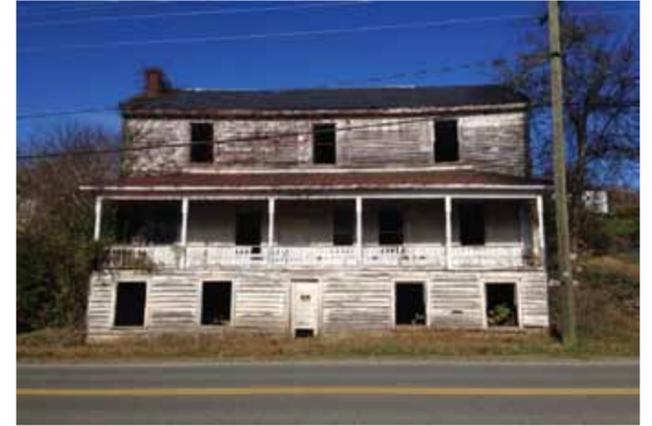
C & D

4. Ferry House (Drawing Reference C&D)

<u>ACM</u>	<u>LOCATION(S)</u>	<u>LABORATORY RESULTS</u>	<u>CONDITIONS (Friable** or Non-Friable, Stable or Damaged)</u>
(1) Wall and ceiling plaster	Interior spaces (intermittent)	0.25-0.5% (Trace***) Chrysotile Asbestos	These trace ACM were friable and in poor condition in many areas

Address: Saint James Street
 Map Numbers: 54A-1-63,
 54A-1-63A
 Owner: Richard T Harry, Jr.
 DHR 200-007 "Ferry House"

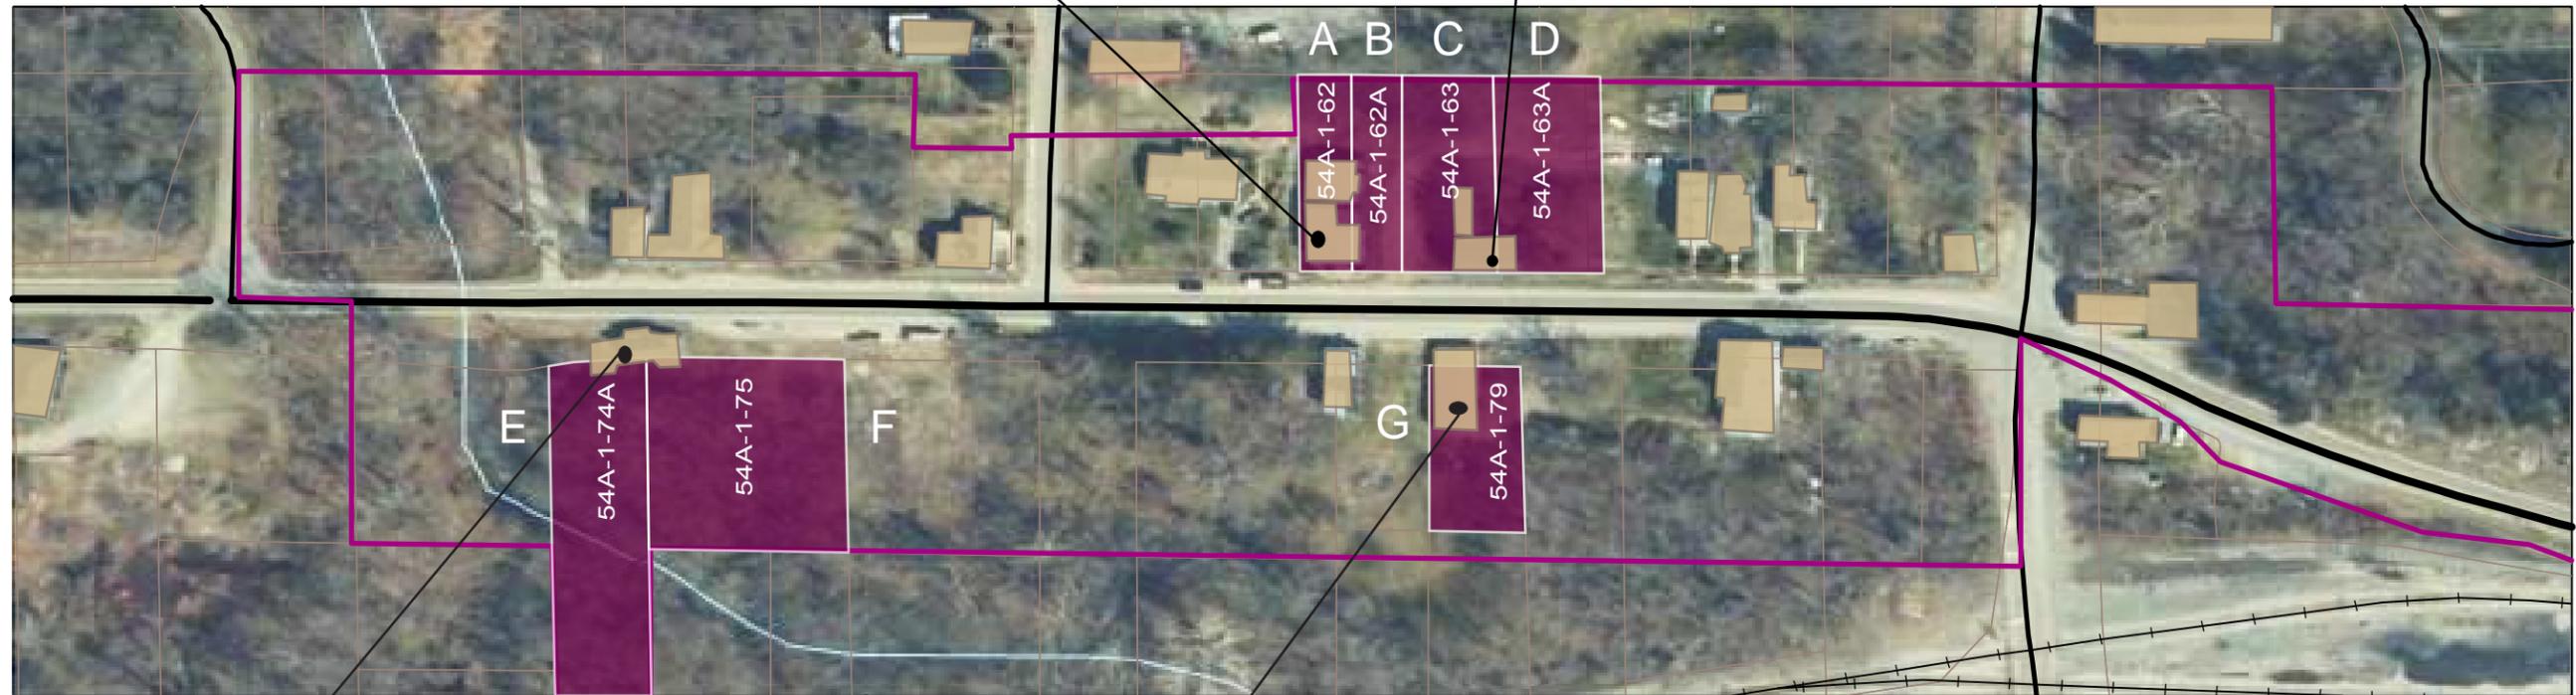
E & F

1. Bryant House (Drawing Reference E&F)

<u>ACM</u>	<u>LOCATION(S)</u>	<u>LABORATORY RESULTS</u>	<u>CONDITIONS (Friable** or Non-Friable, Stable or Damaged)</u>
(1) Roof patching cement	Around chimney flashings on roof	Presumed ACM	These presumed ACM were likely non-friable, and appeared in stable condition at the time of this inspection.

Address: 344 Saint James Street
 Map Numbers: 54A-1-74A, 54A-1-75
 Owner: Richard T & Donna Harry
 DHR 200-0006 - "Bryant House"

- 54A-1-74A and 75 “Bryant House”: Roof patching cement around chimney flashing on the roof.
 - 54A-1-79: Drywall joint compound throughout the inside of the main floor

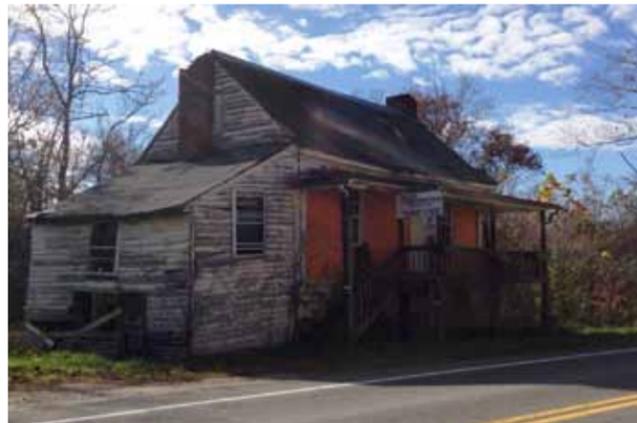
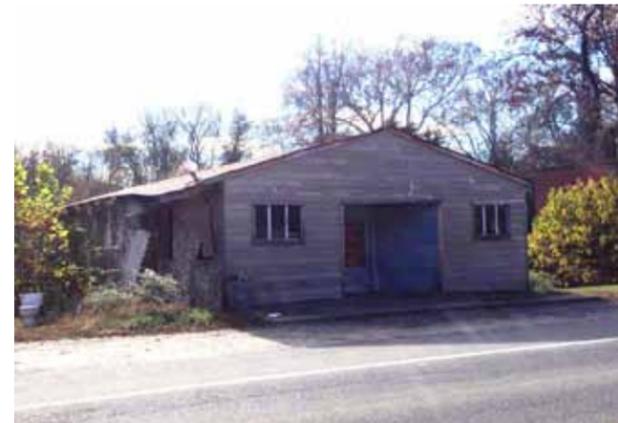
G

2. Harry Jr. House (Drawing Reference G)

<u>ACM</u>	<u>LOCATION(S)</u>	<u>LABORATORY RESULTS</u>	<u>CONDITIONS (Friable** or Non-Friable, Stable or Damaged)</u>
(1) Drywall joint compound	Throughout inside of main floor	0.3-0.5% (Trace***) Chrysotile Asbestos	These trace ACM were friable, but in stable condition at the time of this inspection.

Address: Saint James Street
 Map Numbers: 54A-1-79
 Owner: Richard T Harry, Jr.
 DHR - NONE - Non-contributing
