In 2012, the Thomas Jefferson Planning District Commission (TJPDC), also known as Region 10, started an initiative to study, promote and improve its portion of U.S. Bicycling Route 76 (BR 76). This report is the first step in this initiative, creating an inventory of existing conditions and highlighting recommendations for improving the safety and recreational value of the Route.

This report is a technical document, intended to highlight roadway deficiencies that diminish cycling safety along BR 76, in Region 10. As a technical document, the intended audience includes regional and state transportation planners, along with cycling advocates. This report is intended to document cycling compatibility, with a secondary goal of recording cycling amenities and tourist destinations.

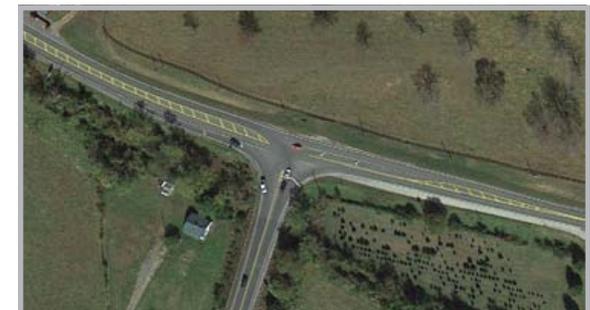
Figure 4-4: VA 976 Intersection

The Rural Long Range Transportation Plan (RLRP) indicated safety deficiencies with this intersection and recommends traffic control improvements, with a possible signal and northbound turn lane or roundabout.

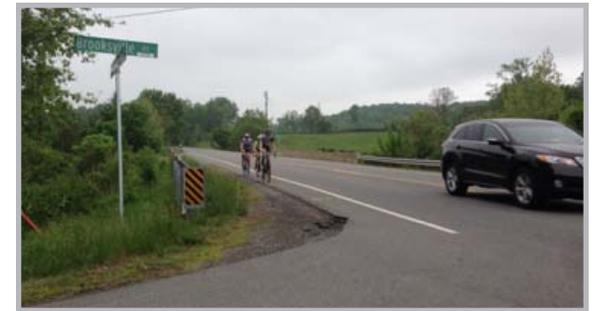
Figure 4-5: Shoulders on US 250

Other than the high volume and speed of traffic, the main cycling hazard in this corridor is the inconsistent shoulder widths. When shoulder widths vary, cyclists may need to swerve in and out of the travel lane, creating unpredictable movements. Particularly with higher travel speeds, these movements can be extremely hazardous to cyclists. (Figure 4-5)

Improved shoulders would be the most effective way of enhancing the cycling environment. The TJPDC should work with VDOT and Albemarle County to implement the recommendations to widen and pave shoulders along this segment. These additional shoulders would provide space for cyclists and improve overall road safety.

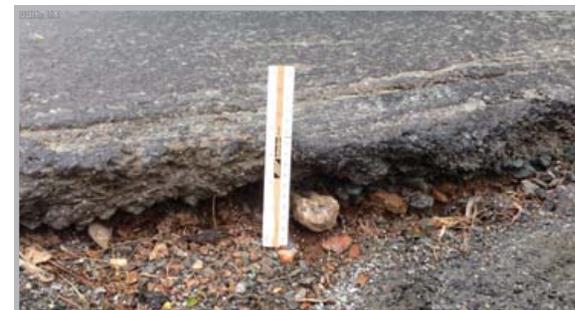
Figure 5-3: Road Edge on Newtown Road

There are no shoulders on this portion of BR 76. Instead, the road edge is framed by vegetative ditches, embankments or drop-offs. (Figure 5-1)

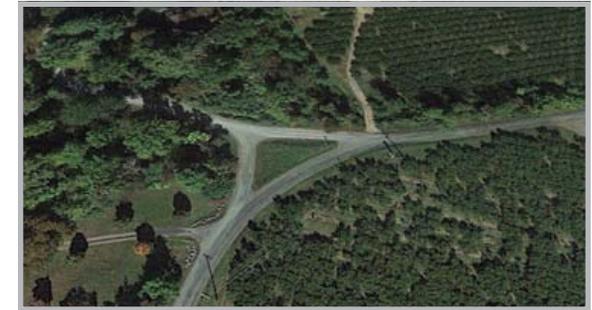
Figure 6-2: VA 611 Intersection

This Y-Intersection includes a channelize turn onto VA 691. The intersection lies on a curve, where Greenwood Road changes into Jarmans Gap Road. The only potential deficiency is sight distance. When vegetation in the island is overgrown, wild grasses can limit sight-lines. There was only one (1) recorded crash within this intersection, between 2005 and 2011. This crash did not involve cyclists. (Figure 6-2)

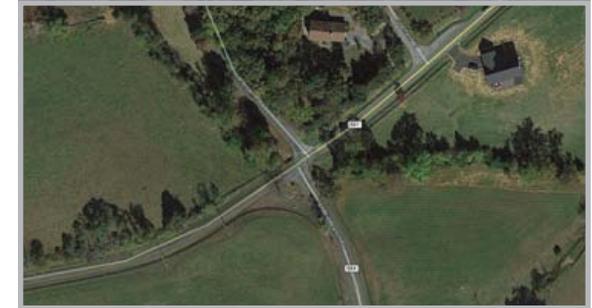
Figure 6-3: VA 684 Intersection

tion. Most of those crashes involved vehicles running off the roadway. (Figure 6-3)

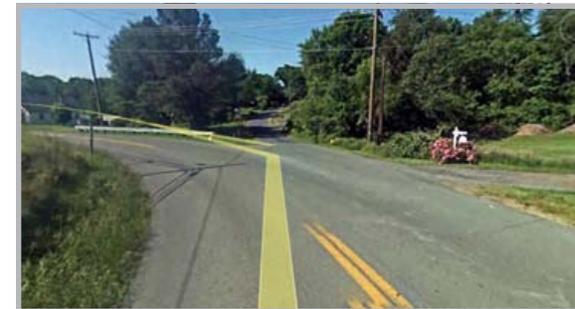
Figure 7-2: VA 810 Intersection

White Hall Road forms a Y-Intersection with Buck Road. While the sight-distances are not ideal, there appears to be sufficient sight-lines for turning vehicles. From 2005 to 2011, there were two (2) off-road collisions at the intersection. (Figure 7-2)

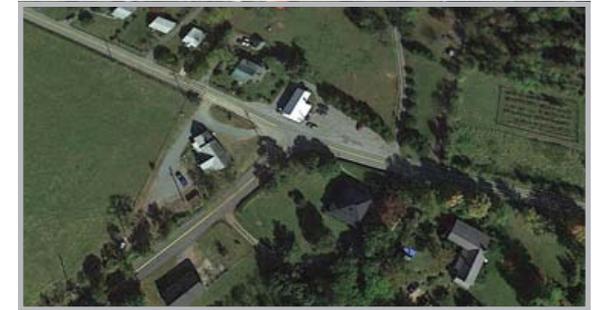
Figure 8-2: VA 614 Intersection

For a rural segment, a relatively high volume of traffic passes through this T-Intersection. A country store essentially creates a fourth leg at the intersection and attracts small amounts of traffic. The main issue at this location is sight distance from White Hall Road, looking east. There is vegetation that obstructs the view of oncoming westbound traffic. These sight-lines may have been a contributing factor in the five (5) crashes that occurred at this intersection, between 2005 and 2011. (Figure 8-2)

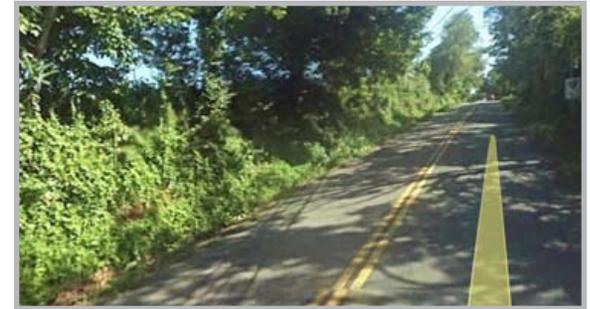
Figure 8-4: Lack of Shoulders on VA 810

In an online questionnaire, several local cyclists communicated their concerns with cycling safety on White Hall Road. One respondent said that the road was too narrow, with poor sight-lines. Another cyclist said that the traffic counts and speeds were too high. Overall, respondents felt that VA 810 was dangerous to cyclists.

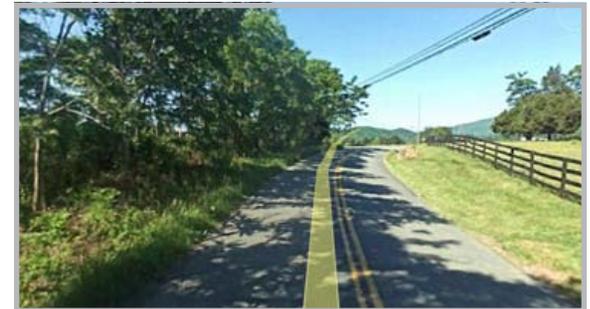
Figure 8-5: Location with Recurring Crashes

From 2005 to 2011, there were 49 crashes on White Hall Road. The most common crashes were off-road collisions with trees, road signs or other roadside features. These accidents tend to reoccur in specific areas, such as the area near Long Meadow Lane. *Note: There are no recorded crashes between motorists and cyclists during this time. (Figure 8-5)*

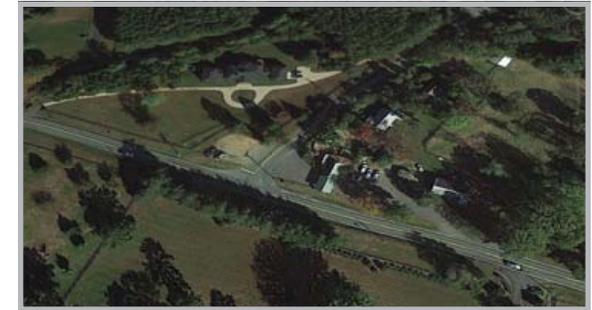
Figure 9-2: Free Union Road Intersection

Between 2005 and 2011, there were ten (10) recorded crashes at this T-intersection. A country store on the northeast corner introduces additional turning movements and conflict points. An embankment in front of the store also creates obstructions to sight-lines. There should be additional study of this intersection to identify deficiencies. (Figure 9-2)

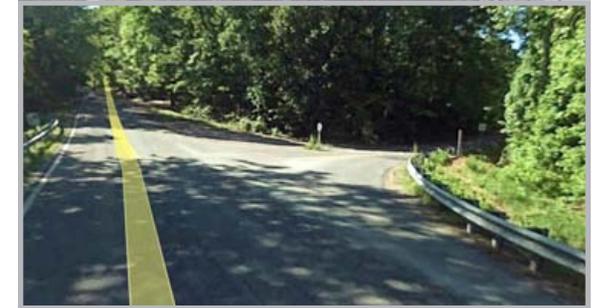
Figure 9-3: Old Garth Road Intersection

Local cyclists expressed concern about this T-Intersection with Old Garth Road. The intersection lies at the bottom of a ravine, which creates higher travel speeds as vehicles gather momentum on the downhill lanes. This may be a contributing factor to the seven (7) vehicular crashes that occurred within this intersection, between 2005 and 2011. *Note: there were no reported crashes that involved cyclists.* (Figure 9-3)

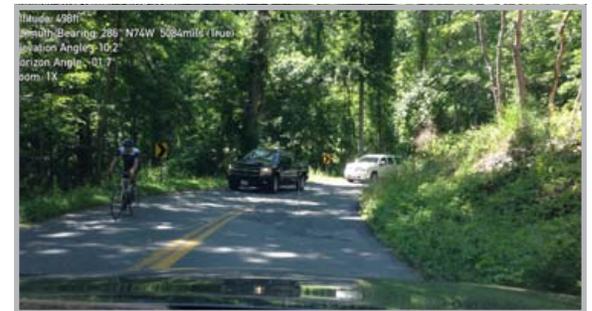
Figure 10-6: Sight-Distance on Old Garth Road

There are several deficiencies with sight-distance throughout this corridor. On Old Garth Road, there are multiple blind curves, due to embankments that obstruct views. This is particularly troublesome on the uphill lanes, where cyclists travel at slower speeds and require more room to maneuver. Also, the intersection with VA 846 presents one of the main hazards in this corridor, due to poor sight-lines. (Figure 10-6)

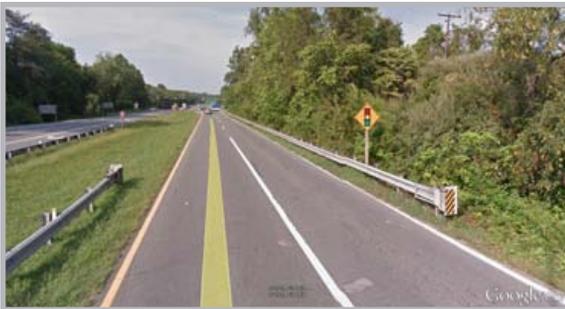
Figure 14-5: Guardrails

between the travel lane and guardrail. Those conditions limit the ability of cyclists to maneuvering away from heavy traffic on US 20. Guardrails can also cause cyclists to feel confined in heavy traffic. (Figure 14-5)

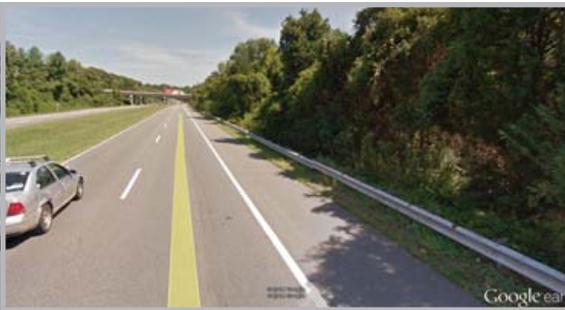
Figure 14-6: Shoulder Conditions

senting cyclists with unexpected changes in road conditions. In some locations there are wide, paved shoulders, while in other road sections the shoulders are gravel or nonexistent. Additionally, the surface conditions vary, as there are potholes and broken pavement along the road edge. (Figure 14-6)

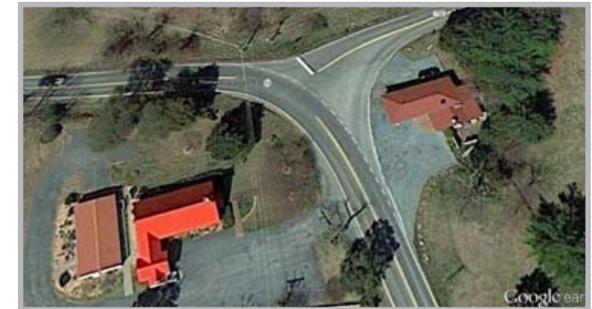
Figure 15-2: Milton Road Intersection

Milton Road connects with US 53 at a curve, creating a T-intersection. While the sight distances are relatively clear, there are additional access points within the intersection, for a church and the Simeon Market, creating additional conflict points on the curve. Generally, vehicles tend to take this curve at higher than recommended speeds. (Figure 15-2)

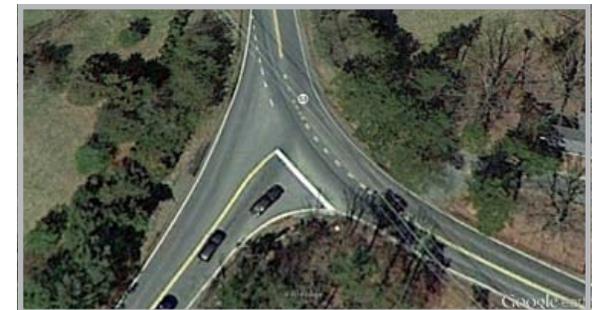
Figure 15-3: James Monroe Parkway Intersection

VA 795 forms a T-intersection with US 53, marking the eastern boundary of Segment A9. While there are no immediate deficiencies at this intersection, there appear to be minor safety issues. While sight distances are adequate, there are limited sight-lines from VA 795, looking west on US 53. Along this area of US 53, there is a business entrance less than 200 feet from the intersection, which could create additional conflict points and confusion between cyclists and motorists. Another issue is the large amount of traffic that passes through the intersection. Between 2005 and 2011, there were at least 17 crashes at this location, making it one of the most accident prone intersections in the Bike Route 76 study area. (Figure 15-3)

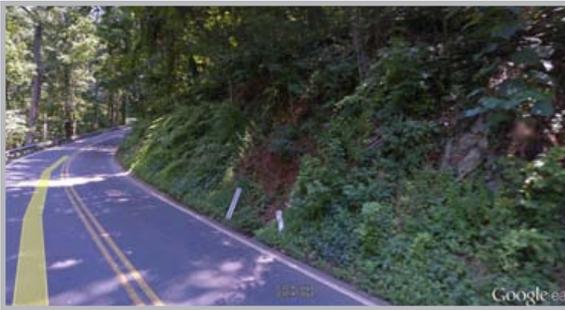
Figure 15-4: Sight Distance at Curve

There are curves with poor horizontal sight distance. These issues are more problematic to cyclists when motorists have blocked sight-lines on the uphill side of the road. (Figure 15-4)

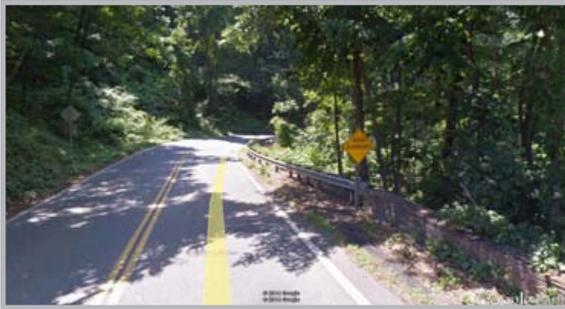
Figure 15-5: Guardrails on US 53

Along US 53, there are several road sections that include guardrails, which can limit the ability of cyclists to maneuver away from the road in cases of emergency. (Figure 15-5)

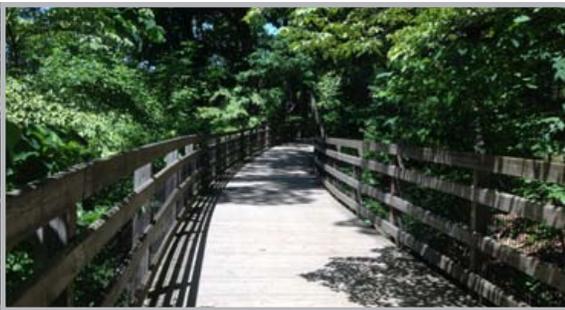
Figure 15-6: Saunders/Monticello Trail

In 2011, the MPO supported a recommendation to reroute BR 76, from US 53 onto the Saunders/Monticello Trail, but due to several concerns regarding compatibility with hikers, VDOT did not adopt this rerouting. While this trail may not be appropriate as a reroute, it could serve as an alternate, so that cyclists could avoid the hazards along US 53. (Figure 15-6)

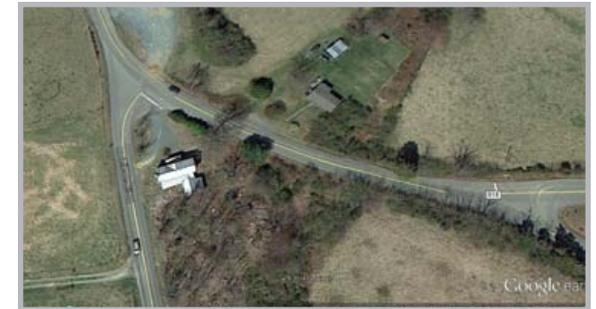
Figure 16-2: Woodridge Intersections

Mill Road) and VA 618 (Martin Kings Road). This cluster of intersections can result in confusion and additional conflict points. There are also limited sight-lines in some locations, due to vegetation or intersection geometry. Between 2005 and 2011, there were 11 crashes in this area. (Figure 16-2)

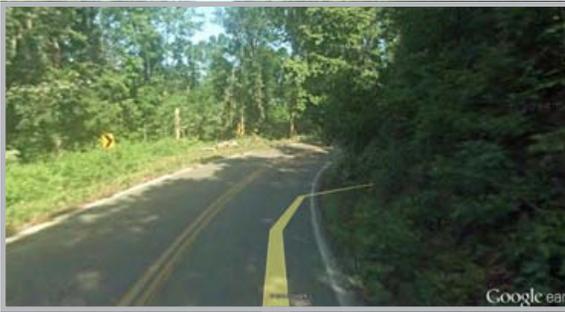
Figure 16-3: Blind Curve

There are select curves with poor horizontal sight distances. The issues are more problematic to cyclists when motorists have blocked sight-lines on the uphill side of the road. (Figure 16-3)

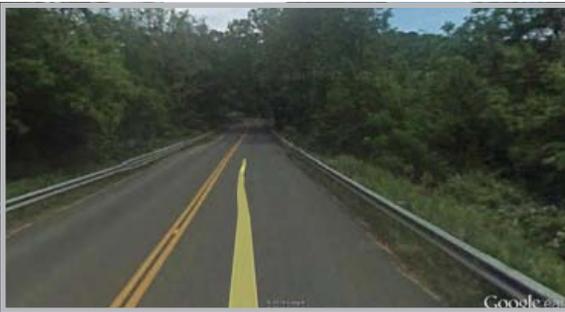
Figure 16-4: Guardrails

On James Monroe Parkway, there are three (3) locations with guardrails, which limit the ability of cyclists to maneuver away from the road in case of emergency. These conditions are particularly hazardous on climbs, where cyclists travel at slower speeds and require additional space to maneuver. (Figure 16-4)
