In 2012, the Thomas Jefferson Planning District Commission (TJPDC), also known as Region 10, started an initiative to study, promote and improve its portion of U.S. Bicycling Route 76 (BR 76). This report is the first step in this initiative, creating an inventory of existing conditions and highlighting recommendations for improving the safety and recreational value of the Route.

This report is a technical document, intended to highlight roadway deficiencies that diminish cycling safety along BR 76, in Region 10. As a technical document, the intended audience includes regional and state transportation planners, along with cycling advocates. This report is intended to document cycling compatibility, with a secondary goal of recording cycling amenities and tourist destinations.

Annual Average Daily Traffic (AADT) and Bike Level of Service (BLOS) by Roadway Segments

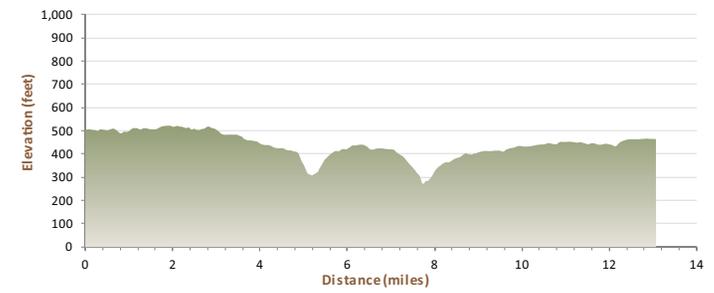
D Bike Level of Service	1,470 Annual Average Daily Trips	45 - 50 Posted Speed (MPH)
9.5' Average Lane Widths (feet)	0' Shoulder/Bike Lane Width (feet)	4% Truck Traffic (percent)

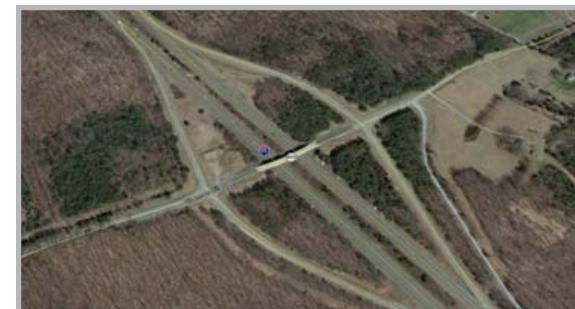
Figure 21-2: Interstate 64 Interchange

This is one of two (2) interstate interchanges within the BR 76 study area. The interchange at Shannon Hill Road is a hazardous environment for cyclists, as there are guardrails and retaining walls at the roadside. There are also high travel speeds and traffic volume. Additionally, the four (4) interchange ramps produce potential conflict points between cyclists and vehicles. (Figure 21-2)

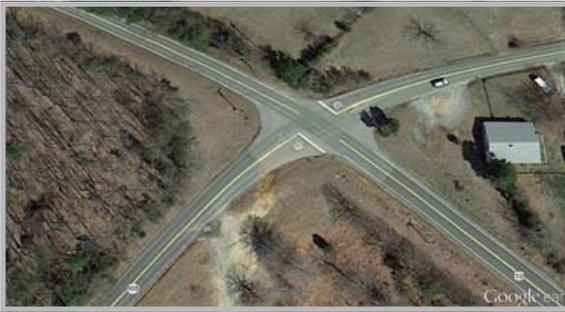
Figure 21-3: Jefferson Highway Intersection

The RLRP identifies safety deficiencies with the US 33 intersection. The plan includes short-, mid- and long-term recommendations to address these deficiencies. In the short-term, the plan calls for improved maintenance of roadside vegetation for sight-distance. The mid-term recommendation is to consider reducing the speed limit. The long-term recommendation is to consider reconstruction to a lower vertical curve, to improve vertical sight distance.

The TJPDC should work with VDOT and Louisa County to provide further study on the intersection recommendations listed in the RLRP.

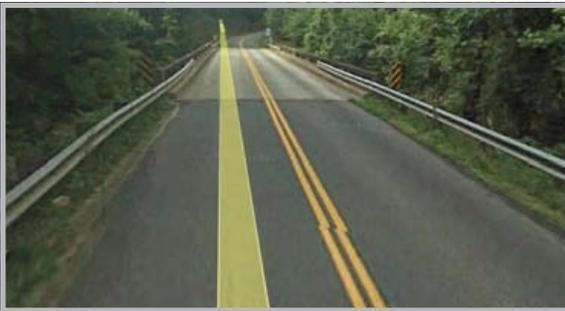
Figure 21-4: Guardrails

There are three (3) locations where guardrails frame the roadway, limiting the ability of cyclists to maneuver away from the road in case of emergency. Locations where guardrails are on the uphill lanes are particularly hazardous to cyclists. (Figure 21-4)

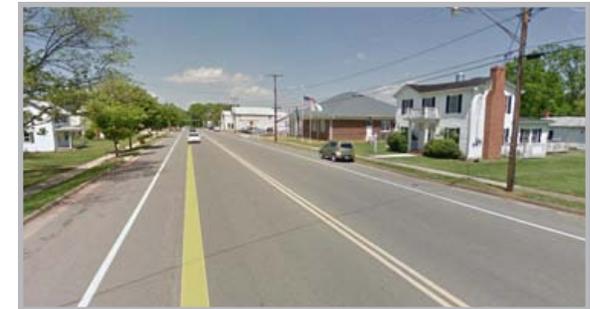
Figure 22-2: Typical Road Section for Mineral Avenue

Another feature that generally concerns cyclists is parallel parking. On Mineral Avenue and 1st Street, on-street parking restricts road widths and present hazards, as open car doors can serve as an abrupt obstacle to riders. Since a low percentage of on-street parking is occupied on Mineral

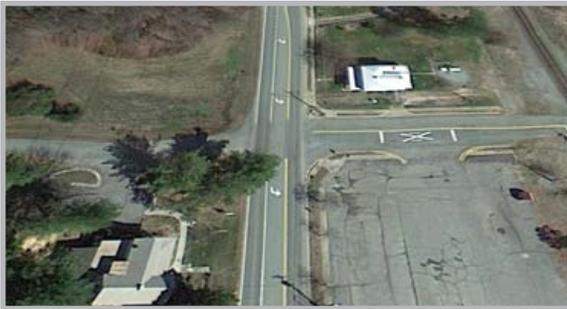
Figure 22-4: Typical Intersection

include: West 6th Street, 5th Street, West 4th Street, West 3rd Street and 2nd Street. Many of these intersections have minor issues with sight distance, as on-street parking or vegetation can obscure sight-lines. (Figure 22-4)

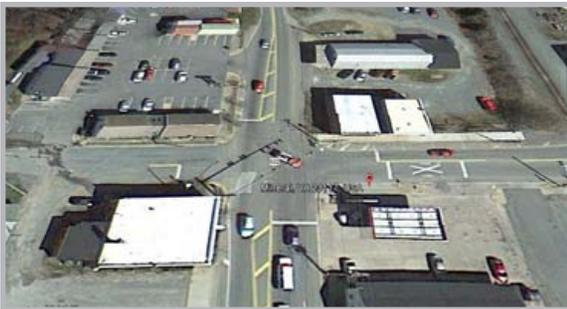
Figure 22-5: East 1st Street Intersection

This T-intersection is a major bottleneck in the community, with relatively high traffic counts. With the railroad crossing on 1st Street, a passing train can essentially close the intersection. In those instances, long traffic queues form behind turning vehicles. With limited turning radii, there are also issues with trucks turning at this intersection, creating potential dangerous situations for cyclists. Tractor trailers and other large vehicles sometimes collide with utility poles and other roadside features, as the drivers attempt this turning movement. In addition to these deficiencies, there are obstructions to sight-lines and multiple conflict points between vehicles and cyclists. (Figure 22-5)

The Louisa County Comprehensive Plan and RLRP identify the East 1st Street intersection as a bottleneck. The RLRP recommends that this intersection be monitored for potential improvements.

The Louisa County Comprehensive Plan recommends the construct of a new bypass, from Route 656 to the Town of Mineral, to relieve the East 1st Street intersection. The RLRP also references this recommendation. There are no timelines or funds dedicated to this project.

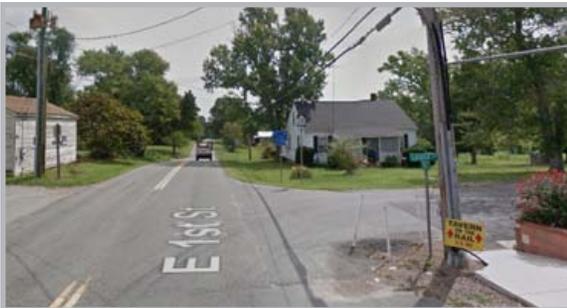
Figure 22-6: Sight-Lines from Louisa Avenue

This T-intersection appears to have several deficiencies related to sight-distance and access management. From Louisa Avenue, vegetation blocks view to the east and west. Consequently, motorists pull into the intersection in order to view oncoming traffic. With access management, there are multiple intersections and entrances within the same general area. Within 200 feet of this intersection, there are two (2) additional intersections, four (4) business/service entrances, and ingress/egress at the firehouse. (Figure 22-6)

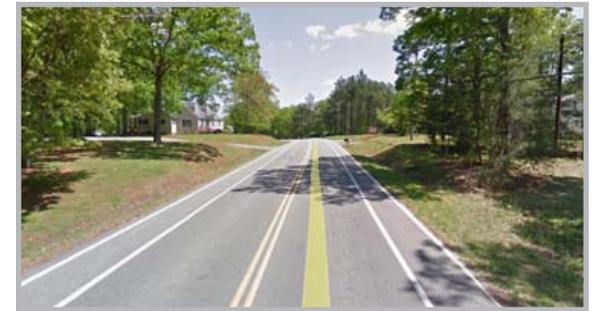
Figure 23-2: Bike Lanes

The BLOS in this corridor varies, based on road and traffic conditions. In the Town of Mineral, VA 618 scored a 'C', where the environment is moderately compatible for cycling. While the traffic counts are relatively high, the speeds are low, at 25 MPH. Once the speed limit increases to 35 MPH, the BLOS score drops to a 'D', which is incompatible for cycling. In combination with the higher speeds, there are no shoulders and relatively narrow travel lanes. The only other location with a BLOS C is at the bike lanes near Spring Road.

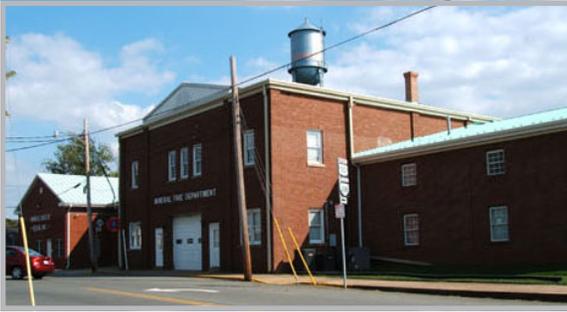
Figure 23-4: Mineral Firehouse

The Mineral Firehouse provides lodging for cyclists and serves as a destination for cyclists. The fire department also trains their crews in first aid, which could be important for cyclists who sustain injuries. There are several businesses in the town that offer services that are useful to cyclists. (Figure 23-4)

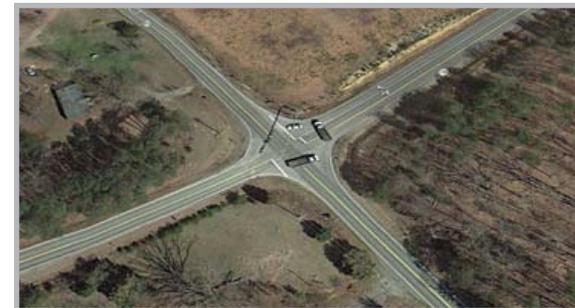
Figure 24-2: Johnson/Kentucky Springs Road

This intersection experiences additional traffic because of its location and function. The northern leg is the only access point for the North Anna Power Station. The southern leg takes travelers towards the Town of Mineral, whereas the east and west legs provide access to residential subdivisions and destinations along Lake Anna. Because of the additional traffic, this is one of the only signalized intersections in the rural portions of the study area. (Figure 24-2)

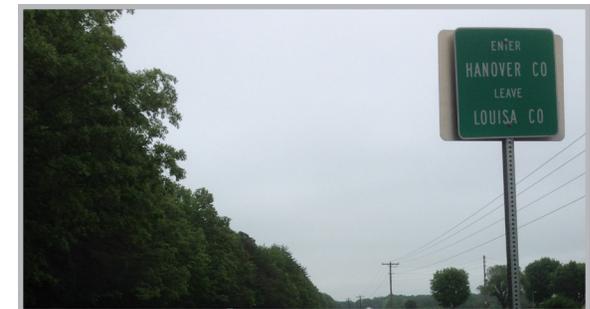
Figure 25-3: Hanover County Line

Traffic counts vary in the Bumpass area. Pottiesville Road carries the lowest traffic counts, as would be expected for a local road, with 588 ADT. The highest volumes are on the Fredericks Hall Road segment, with 1,563 ADT. Near the Hanover County line, there are 1,919 ADT on Belsches Road.

County line. Most of the crashes in this area involved off-road crashes, with roadside features such as trees or road signs. *Note: There are no recorded crashes between motorists and cyclists, between 2005 and 2011. (Figure 25-3)*
