**NATIONAL REGISTER OF HISTORIC PLACES
REGISTRATION FORM
FOR**

**FIFEVILLE-CASTLE HILL HISTORIC DISTRICT
CHARLOTTESVILLE, VIRGINIA
DHR # 104-0213**

**PREPARED BY: MARAL S. KALBIAN, ARCHITECTURAL HISTORIAN
MARGARET T. PETERS, RESEARCH HISTORIAN**

October 2007

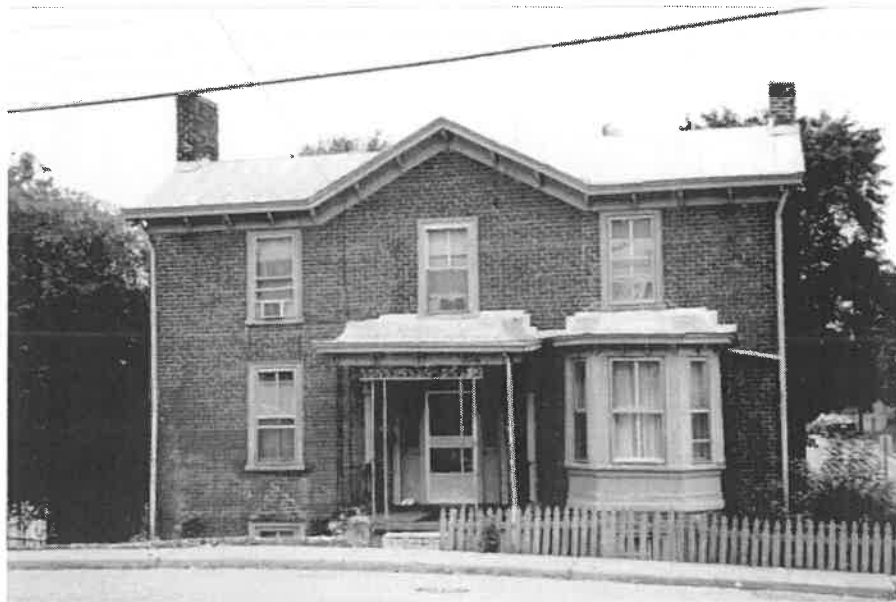
6

The Shelton-Fuller House at 301 5th Street SW [104-0213-0001] is the third of this group of fairly large vernacular brick I-houses constructed in the mid-19th century on land in the eastern part of the district (**Photo 6**). Constructed ca. 1870 by John Fry, probably on speculation, the 2-story, 3-bay brick dwelling features a façade laid in a 7-course-American-with-Flemish-bond pattern and the side and rear walls and raised brick foundation laid in 7-course American bond. The house is an example of a fairly ornate Victorian interpretation of the common vernacular I-house form and has a bellcast standing-seam metal gabled roof, deeply overhanging bracketed eaves, a central front gable, 2/2-sash wood windows, two semi-exterior-end brick chimneys that pierce through the eaves, and a 5-light transom and 3-light sidelights around the front door. Both the projecting polygonal front bay window and the 1-bay front porch have mansard roofs. The use of a shallow mansard roof as a decorative element on a porch or projecting bay window was observed on approximately 15 dwellings in the district. This late-19th-century Victorian feature is somewhat unique to this area of Charlottesville and may be associated with a particular builder, who as of this time has not been identified.

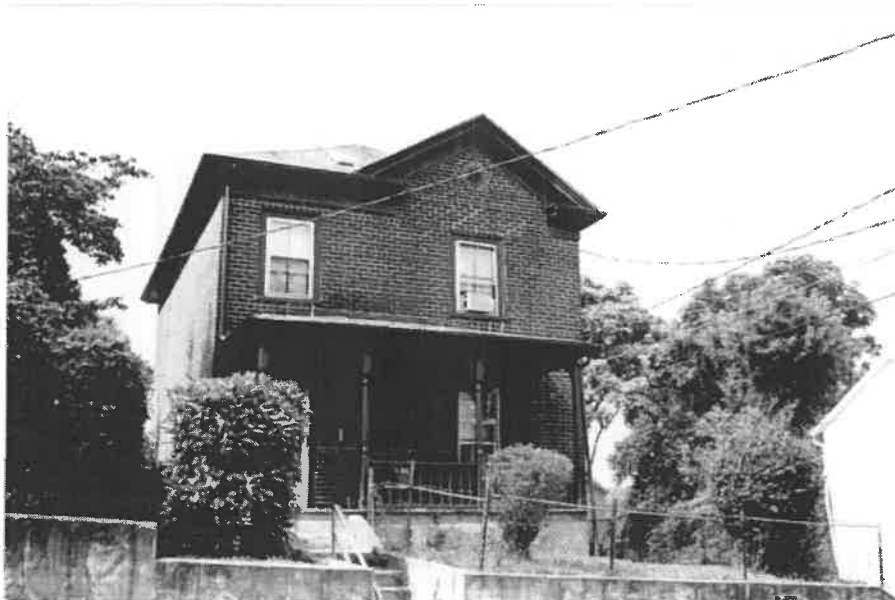
10

Not all examples of this type of cross-gabled dwelling are constructed of frame. The house at 610 Dice Street [104-0213-0106] is of brick construction laid in 6-course American bond (**Photo 10**). The extremely well-preserved, 2-story, 2-bay, side-passage-plan, brick dwelling has a hipped roof with cross gables. The house features a plain brick frieze (like those found on other brick houses on 7th Street and 7½ Street near the Updike brickyard), gable-end returns, round wooden attic vents, 2/2-sash windows, overhanging eaves, a transom over the front door, and a 3-bay front porch with turned posts and spindle brackets. The house was constructed ca. 1910, nearly 20 years after some of the earlier examples of this type, a testament to the popularity of this form in the district. The brick house at 602 Dice Street [104-0213-0108] also displays this form, but it has been stuccoed.
